## Re-Use Guidelines

### Hangar 2 (Building No. 46) NASA Ames Research Center Moffett Field, California

August 30, 2006

Prepared by  
**PAGE & TURNBULL, INC.**  
San Francisco, California

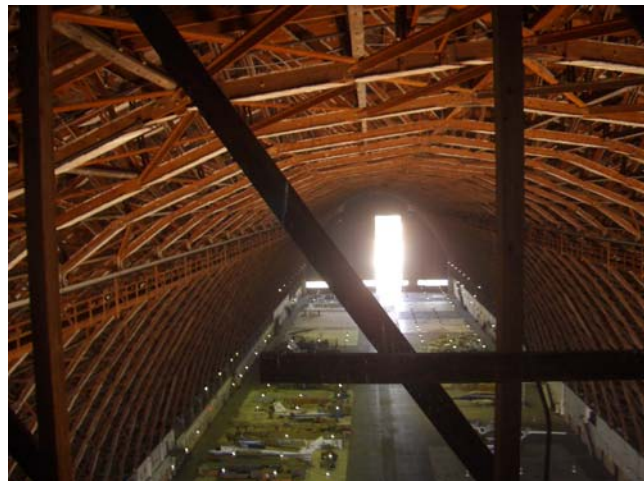
**Figure 40. Upper arc of truss assembly, south end, Hangar 2.**

creosote-treated outer layer, the trusses appeared to be in fair condition. Every truss appeared to be intact, no significant out-of-plane movement was noted, and no significant cracking, rot or loss of subcomponents was observed. It was not possible to assess the metal split ring connectors within the truss assemblies. Visible metal subcomponents, such as the gusset plates and bolts connectors were exhibiting rust.

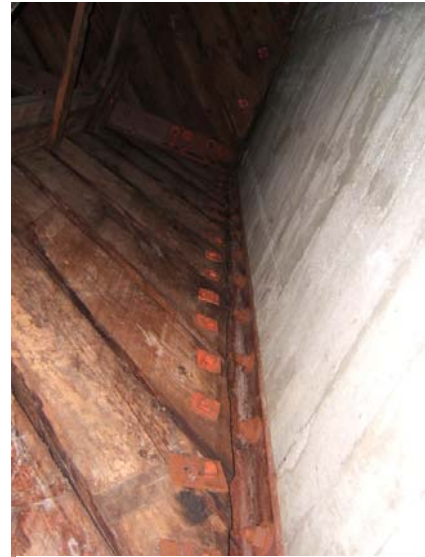
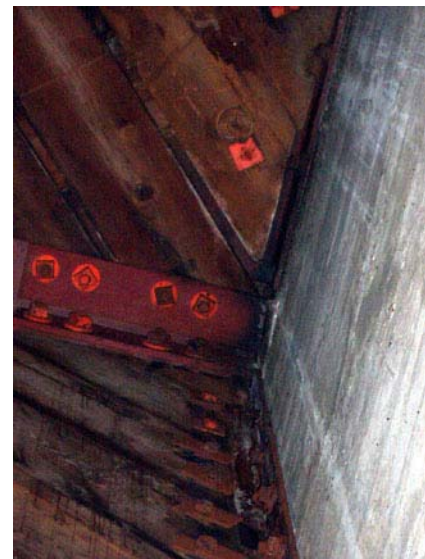
**Figure 41. Angle iron union of box girder and corner tower, Hangar 2, interior of box girder northeast corner girder.**

**Figure 42. Detail of angle iron at juncture between box girder and corner tower, Hangar 2, interior of box girder, northeast corner.**

The lintel between the door towers is hollow. It is framed with a double-height truss system. The walls and ceiling are clad with 2 in. tongue and groove diagonal sheathing. The floor of the door girder is approximately 8 in. thick and composed of three layers of planking. Salt deposits were found on all the surfaces of the truss members inside the box girder. A steel angle iron connector unites the wood walls of the lintel to the interior concrete walls of the door towers and the steel and bolts are badly corroded, further suggesting the presence of water in the space (**Figures 41 & 42**).

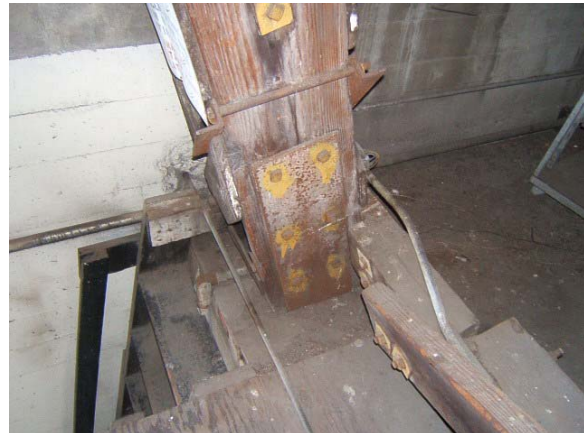
There is rusting and salt damage on the connection plates between the wooden truss members and concrete bents (**Figure 49**). A structural engineer should assess the number of bolts connecting the wood trusses together and the trusses to the concrete bents. The connectors are, at best, in Fair condition. They are showing the early signs of wear, as evidenced by the rust, and require routine maintenance.

**Figure 49. Interface between wood truss and concrete bent (Bent #1, west junction).**

- Consult with a Structural Engineer regarding the integrity of the interface between the wood trusses and the concrete bents. In particular, examine the number of bolts used to attach these two materials and the condition of the metal.
